## **MONITORING OF VERTICAL SHIFT OF HOLY-TRINITY CHURCH IN ŽILINA**

**J. Mužík, M. Mancovič, I. Šnauková, A. Villim**

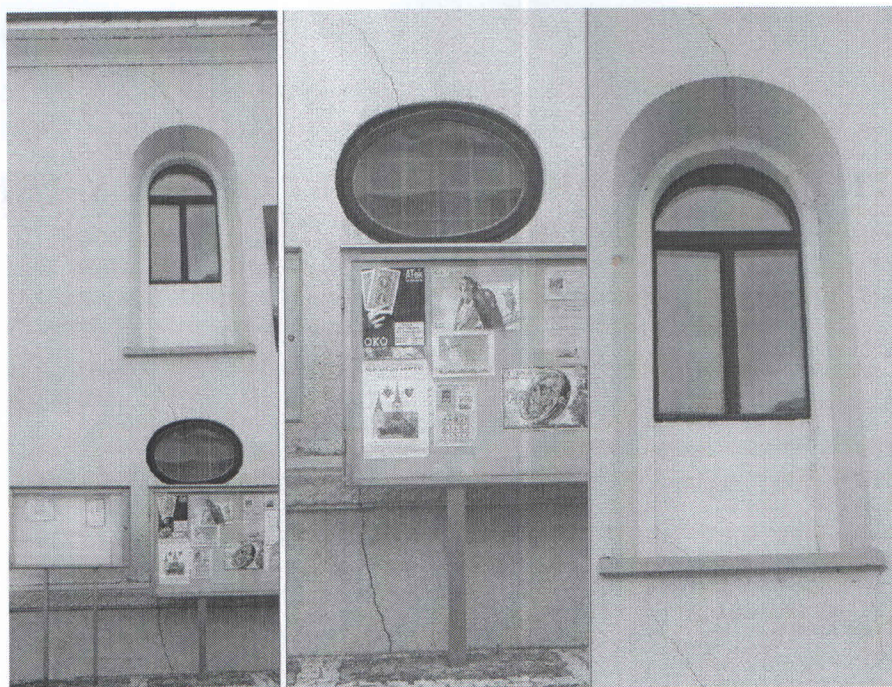
The building of a shopping centre in the vicinity of the church began in november 2008 by digging the foundation base hole. In the end of January the old splits and tears appeared as well as new splits and tears on the floor and the walls of the church (Picture 1). The splits and tears were probably created by the influence of the construction of a shopping centre which caused an unfavourable change on the subbase of the church. Therefore it was decided to make the geodetical measurements of the height changes of the church to find out the real size of the sinking. The bearing of the basic phase began 2 months after digging out the foundation base. By this time there were already visible tears and splits on the church building.

Figure 1: The splits and tears on the church

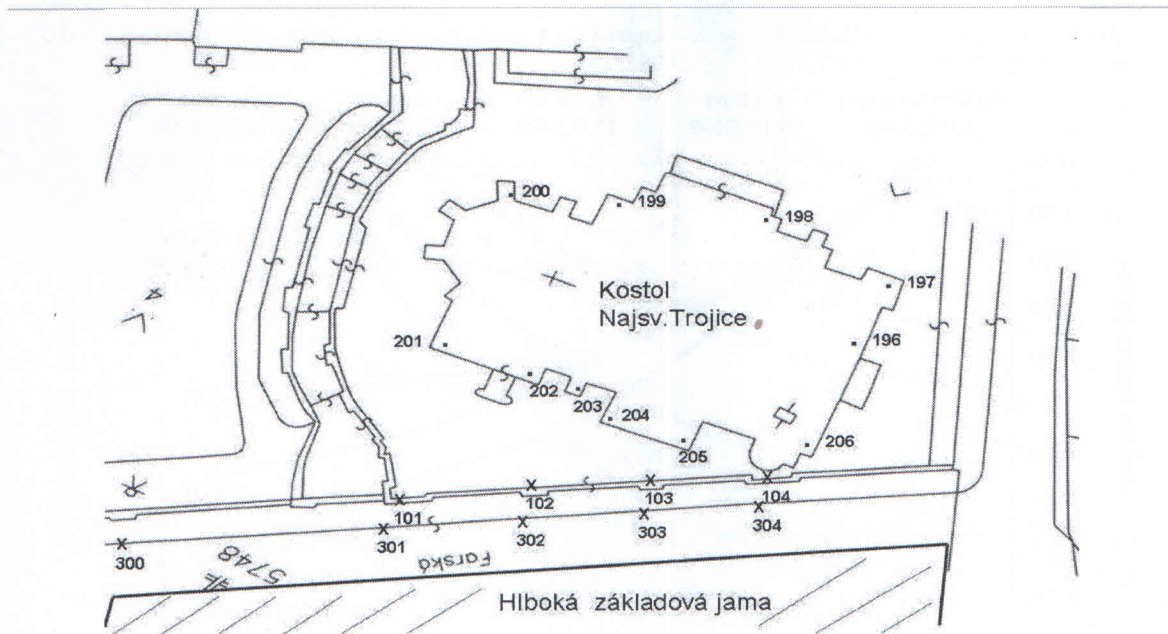
The distribution of the observed points is to be seen at Picture 2. The pavement is on the level of the terrain sloping downwards from the edge of the houses surrounding the Marianske namestie (Marian square) and is represented by the points 300, 301, 302, 303, 304. The balustrade is the horizontal courtyard of the church and because of its height it is separated from the adjacent pavement and stabilized by the points 101, 102, 103, 104. The adjacent side of the church to the construction hole is represented by the points 201, 202, 203, 204, 205 and the outlying side of the church - 200, 199, 196 and its front side by the points 206, 196, 197. These points mark the ground plan of the church which base plate is on the same level as the balustrade.

Figure 2: The observation points

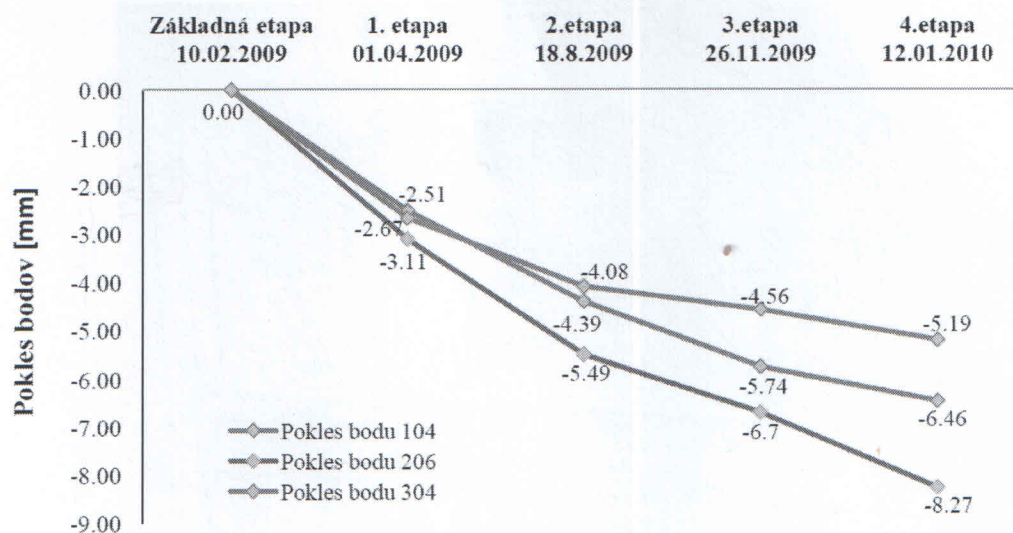
The greatest vertical traverse was observed at the point 206 located closest to the base hole, approximately 15 metres while the depth of the hole is similar. The decline of the point also grew after constructing the underground garages up to the level of the terrain and to 12th January 2010 the result of a sinking of 8.27 milimetrs was noticed. – Picture 3.

An interesting process (course) was allocated of the height changes the following points have – 300, 301, 302, 303, 304, where the point 300 is located in the original build up area, approximately in the middle of the preserved object and the lower terrace of the balustrade. It shows an increase from the beginning of the measurements as if the zone of the sinking of the original slope in the neighbourhood of the construction site would cause the lift of the undisturbed and unlimited surface of the pavement, the building and the supportive wall of the balustrade.

Figure 3: Shifts to the points

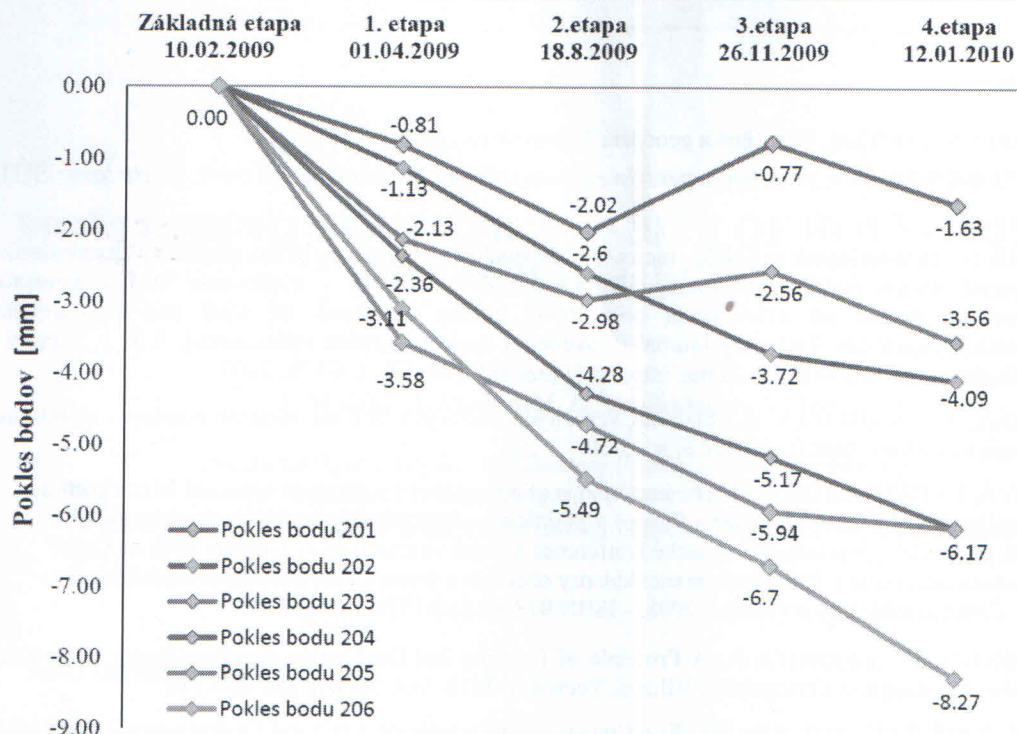
The uneven development of the height changes is recorded also at points 201, 202, 203, 204, 205, 206. This process of sinking is dependant on the distance of the point to the construction site. The point 201 has the longest distance therefore it shows the smallest sinking. The gradual approximation of the points to the base stone (basement) of the building manifests the greatest sinking.

The presented results of measurement account for significant traverses on the observed points. During the course of 11 months the point 206 recorded as much as 8.27 mm. On the contrary the point 300 which is a part of the pavement showed lift. The traverses were also manifested after constructing underground garages up to the level of the ground, but also when constructing above ground garages. The measurement was finished in the middle of January 2010 before the inspection of the building.

Figure 5: Shifts of points located on the Church
